# PHASE ONE ENVIRONMENTAL SITE ASSESSMENT

# 157 and 165 Cross Avenue, Oakville, Ontario

BIGC-ENV-623A

September 7, 2023

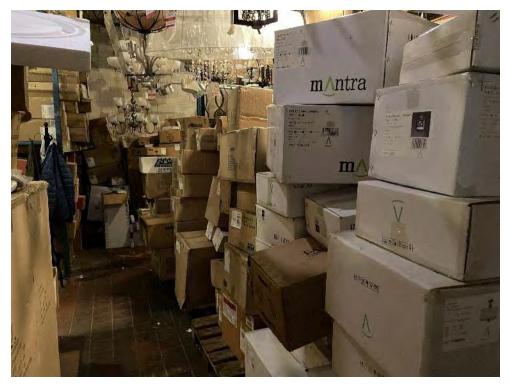
Photo 2: View of the storage area at 157 Cross Avenue.

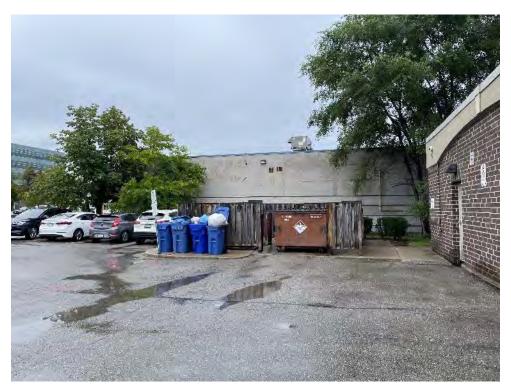
Photo 4: Waste storage area at the back of the Site building at 165 Cross Avenue, facing east. One (1) transformer is in the wooden shed of the waste storage area. Based on the year of Site redevelopment in 2008, it is unlikely to contain PCBs.

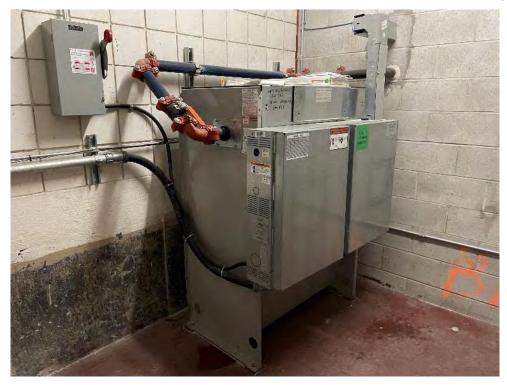
Photo 5: The hydraulic oil AST at the back of the Site building at 165 Cross Avenue, used for the elevator, no leaks have been reported.

The presence/absence and condition (if present) of ASTs at the Site was assessed during the Site reconnaissance. BIG observed an AST for hydraulic oil that powers the elevator in the mechanical room at the back of the Site building at 165 Cross Avenue during the Site reconnaissance. The Site representative had no knowledge of any historical ASTs. The Site at 165 Cross Avenue is associated with PCA#28 – Gasoline and Associated Products Storage in Fixed Tanks.

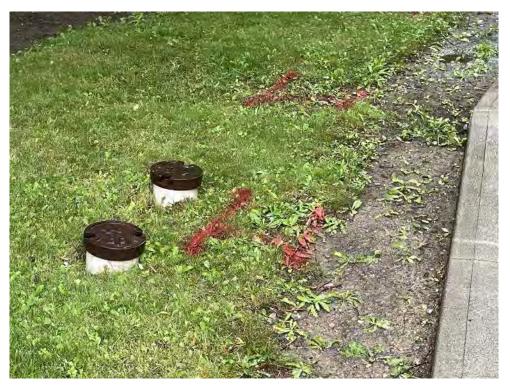
Photo 6: Two (2) water supply wells were observed at the Site east of the Site building at 165 Cross Avenue.

Two (2) water supply wells were observed at the Site east of the Site building at 165 Cross Avenue. According to the Site representative, the water wells are only used for the sprinklers. The Site is supplied by the municipal water system.

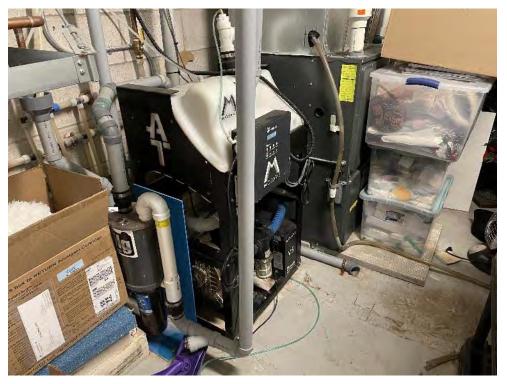
Photo 9: Disinfection system for the dental office at 165 Cross Avenue.

General purpose cleaning supplies, and disinfectants for the dental office were observed in the storage room on the ground floor. No spilling or staining was observed on the surrounding floors.

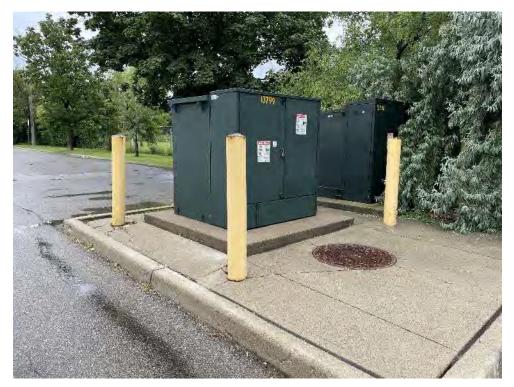
Photo 14: Two (2) transformers were located east of the building at 125 Cross Avenue, west adjacent, facing northeast. Based on the label, they were manufactured in 2017, which are unlikely to contain PCBs.

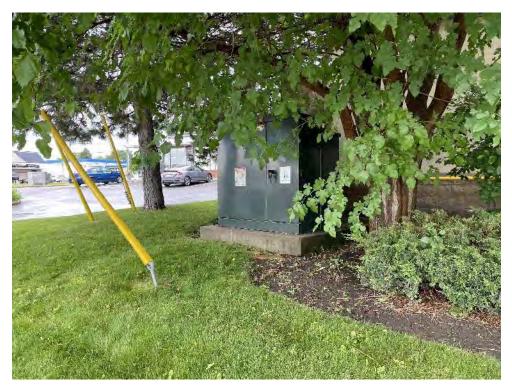
Photo 18: One (1) transformer was observed at the property located at 217 Cross Avenue, approximately 140 m northeast. Based on the label, it was manufactured in 2003, which is unlikely to contain PCBs.

One (1) transformer was observed at the property located at 217 Cross Avenue, approximately 140 m northeast. Based on the label, it was manufactured in 2003, which is also unlikely to contain PCBs. However, as it is unknown if an older transformer was previously present, it is associated with PCA#55 – Transformer, Manufacturing, Processing and Use.

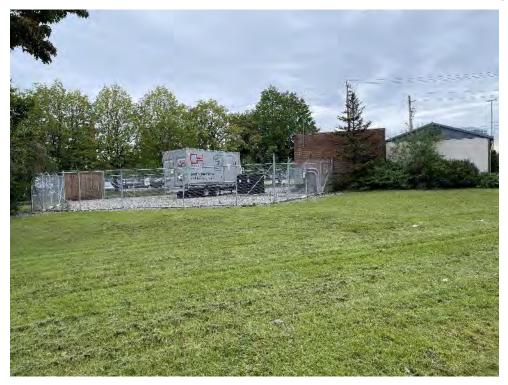
Photo 19: The property located at 539 Lyons Lane, approximately 150 m southwest, is occupied by a power station with a transformer.
