# PHASE ONE ENVIRONMENTAL SITE ASSESSMENT

## 166 South Service Road, Oakville, Ontario

BIGC-ENV-457B

November 10, 2022

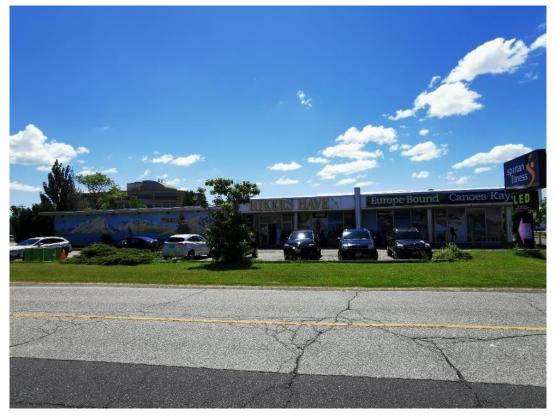
Photo 1: Frontage of the Site building, facing southeast.

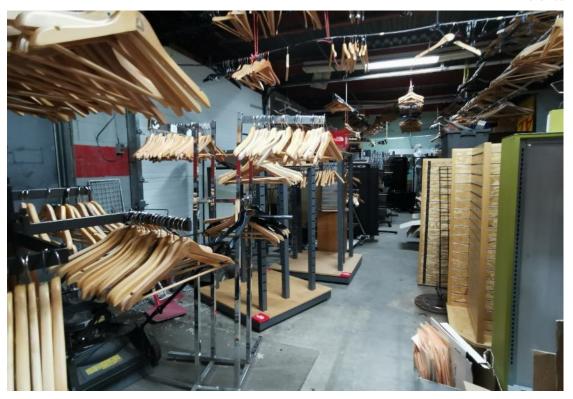
Photo 5: Storage room within the Site building at Hikers Haven.

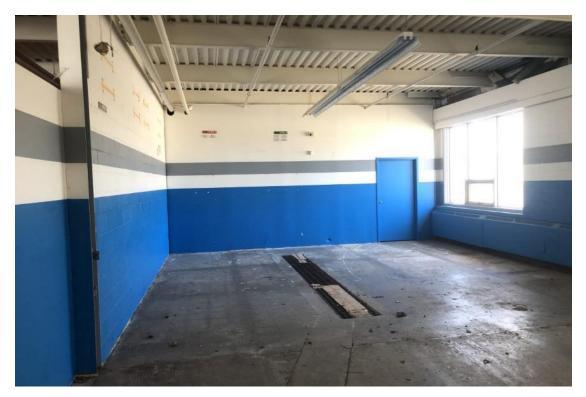
Photo 6: Interior of Site building with floor drain in eastern portion.

Based on the Site reconnaissance, a drainage ditch is located along South Service Road East. Floor drains are located in the eastern portion of the Site building. No other drains, pits or sumps were observed during the Site reconnaissance.

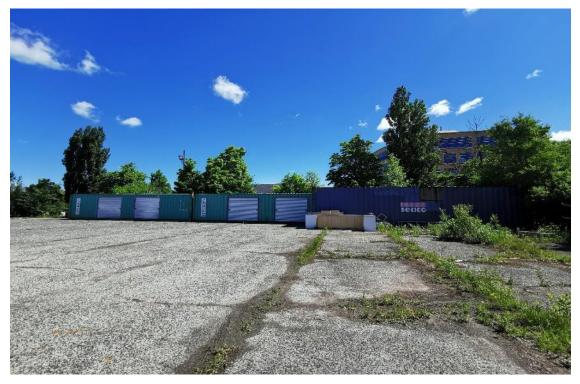
Photo 7: Storage containers located at the northeast central portion of the Site, looking northeast.

The Site is well maintained. A roll-off bin for waste storage was observed at the central portion of the Site and three (3) shipping containers used for storage, two (2) garbage bins and three (3) recycling bins were observed in the central portion of the Site. No other debris, outdoor storage, or uncontrolled waste storage were noted during the Site reconnaissance.
