# **PHASE ONE** **ENVIRONMENTAL SITE** **ASSESSMENT**

**590 Argus Road, Oakville, Ontario**

BIGC-ENV-554D

April 28, 2023

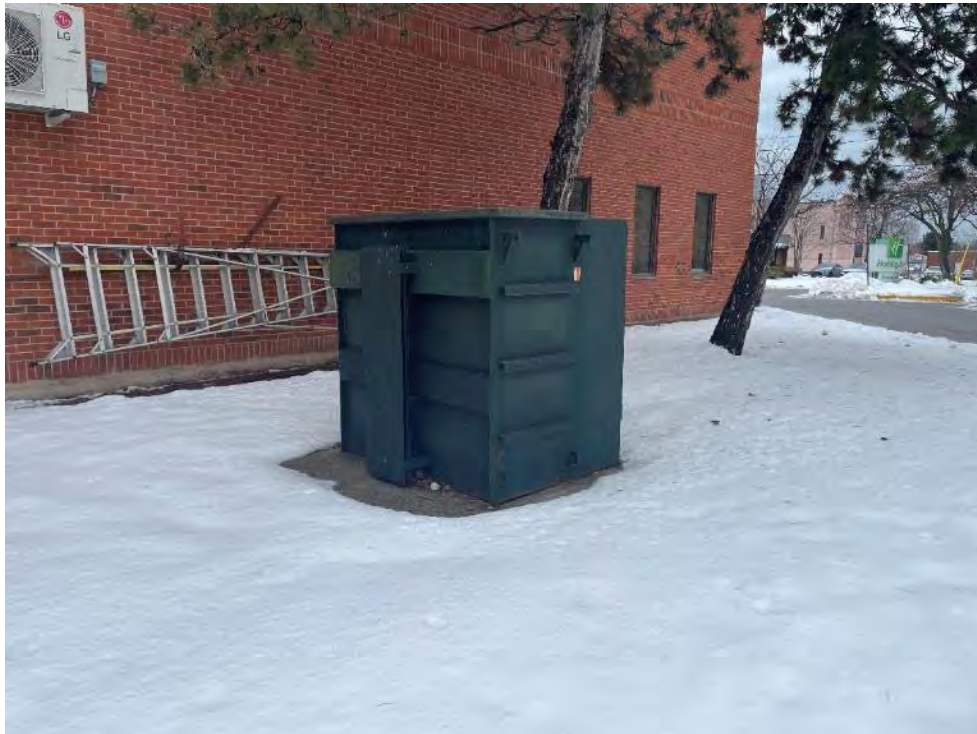
One (1) transformer was located on site to the west of the Site building. It was mentioned that it was likely installed after the 1980s. One (1) transformer was observed at the property located at 234 South Service Road, north adjacent. One (1) transformer was observed at the property located at 562 Trafalgar Road, approximately 170 m east. The Sites with transformers are associated with PCA#55 – Transformer, Manufacturing, Processing and Use.

Photo 3: Transformer located on-Site to the west of the Site building, facing southeast.

3.			#55 – Transformer Manufacturing, Processing and Use	A transformer was observed on-Site to the west of the hotel building during the Site reconnaissance. It was mentioned that it was likely installed after the 1980s.

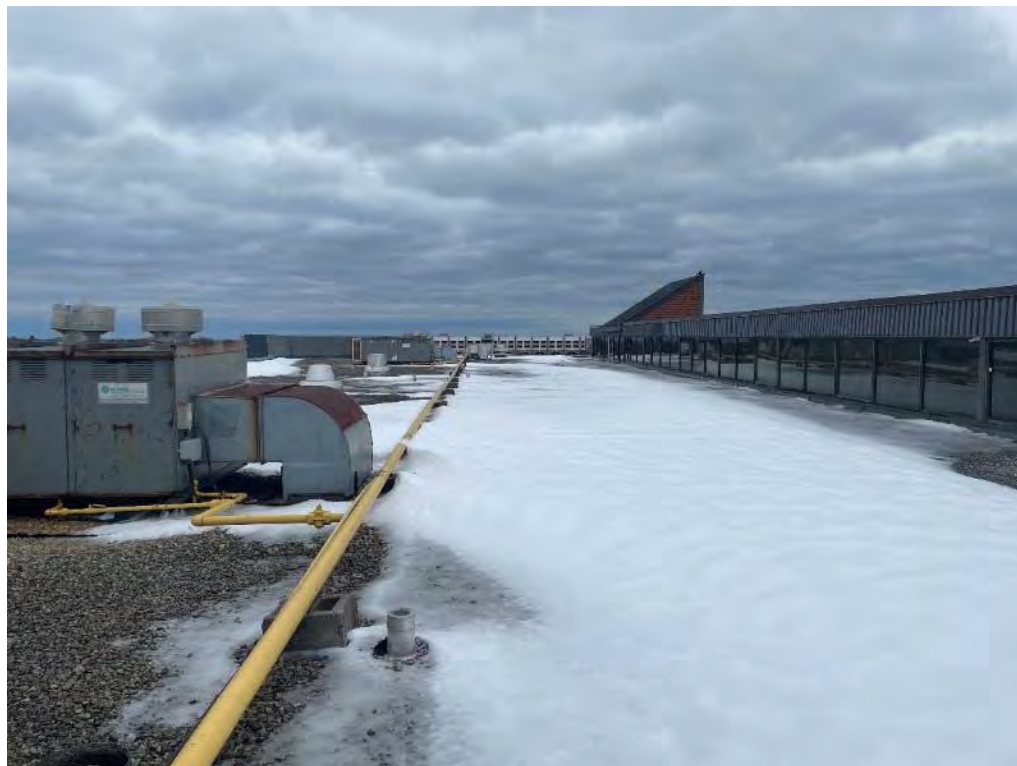
Based on the Site reconnaissance, the Site building was heated by roof top natural gas fired heating and roof top ventilation and air conditioning system. Air conditioning units were used to cool the Site building.

Photo 4: Roof of Site building, facing east.

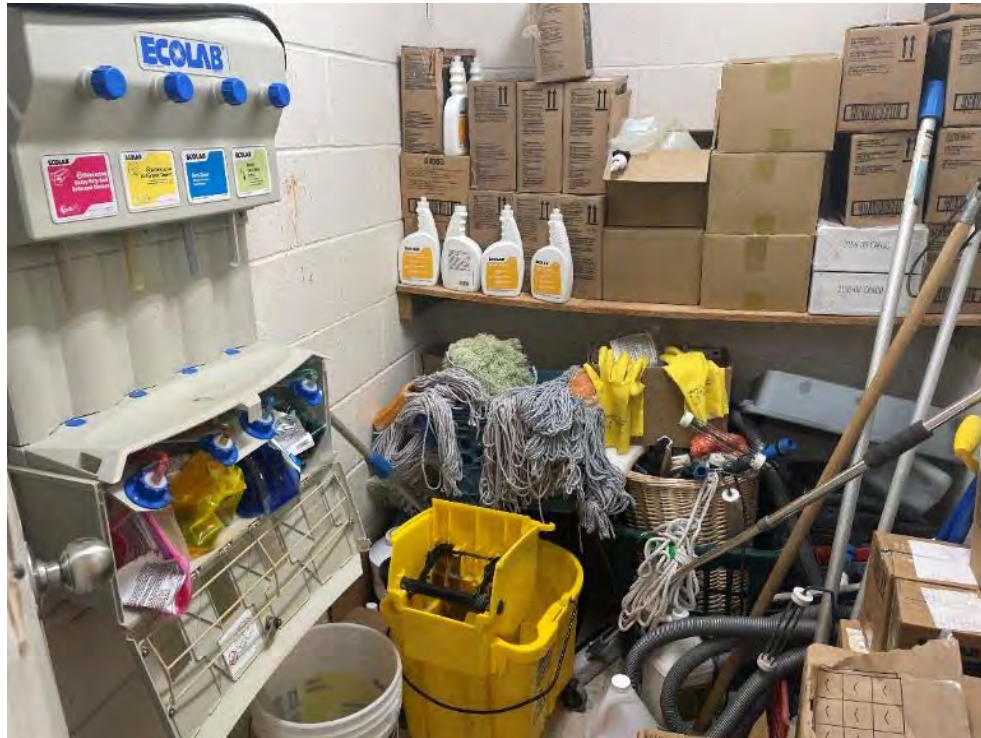
General purpose cleaning supplies, and swimming pool additives were observed in the basement level. No spilling or staining was observed on the surrounding floors.

Photo 7: Cleaning product storage room in Site building.

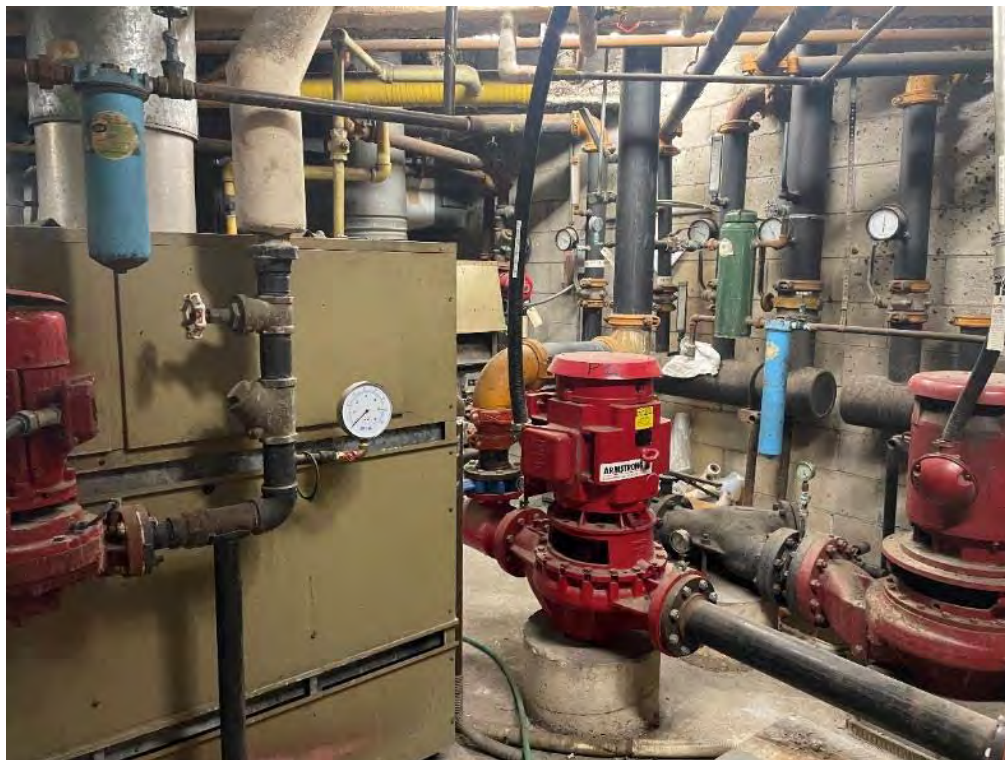
Photo 8: Mechanical room in Site building.

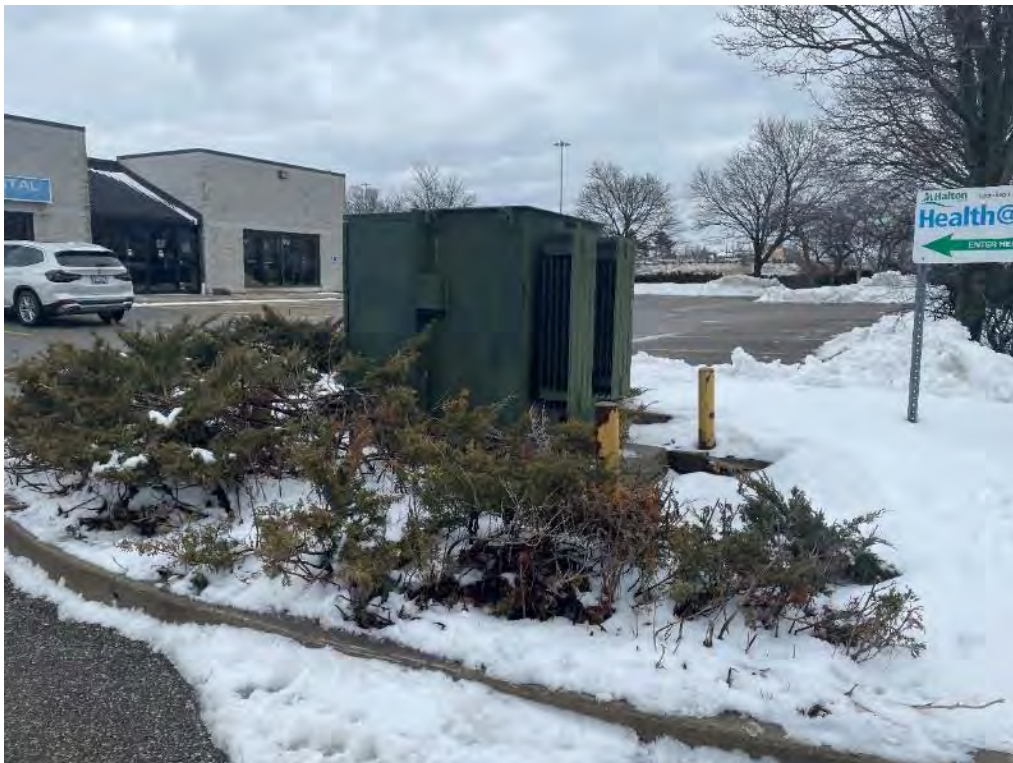
Photo 16: Transformer located at east adjacent property, 234 South Service Road East.

6.	234 South Service Road East	Off-site (east adjacent)	#55 – Transformer Manufacturing, Processing and Use	Based on the BIG Site reconnaissance, a transformer was observed at 234 South Service Road East.	None PCBs are immobile

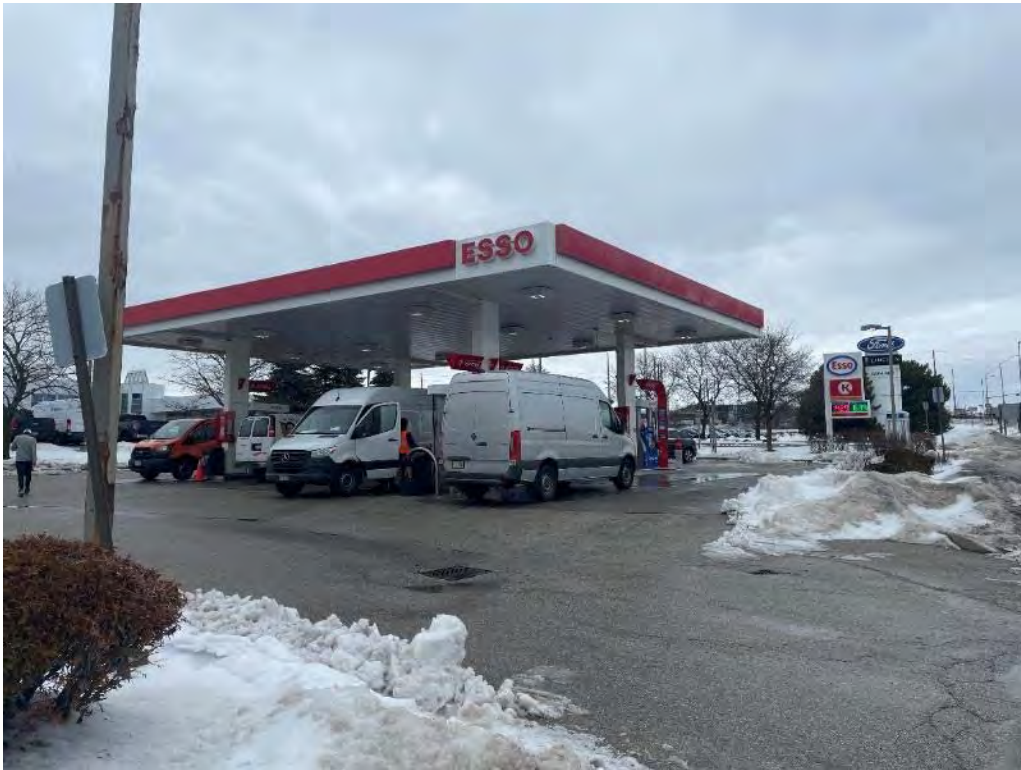
Photo 17: Gasoline service station located at 562 Trafalgar Road, approximately 170 m east.

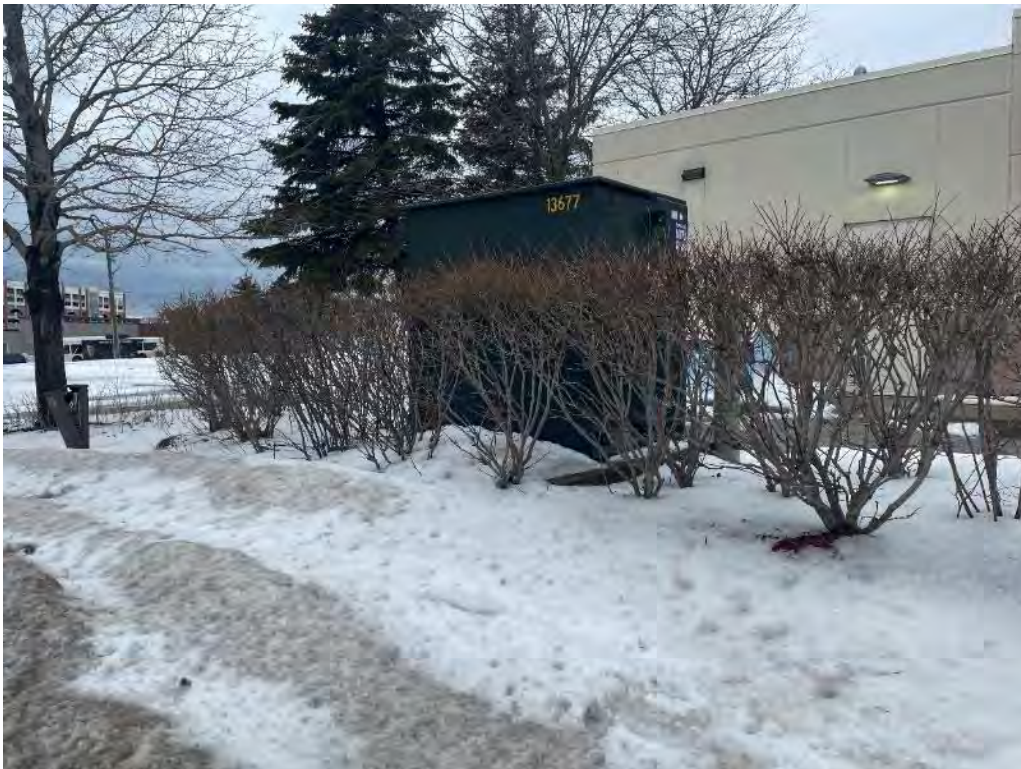
Photo 18: Transformer located at 562 Trafalgar Road, approximately 170 m east.

17.			#28 – Gasoline and Associated Products Storage in Fixed Tanks		
18.			#55 – Transformer Manufacturing, Processing, and Use	Based on the BIG Site reconnaissance, one (1) transformer was observed at the property located at 562 Trafalgar Road, approximately 170 m east. The year of manufacturing was not identified.

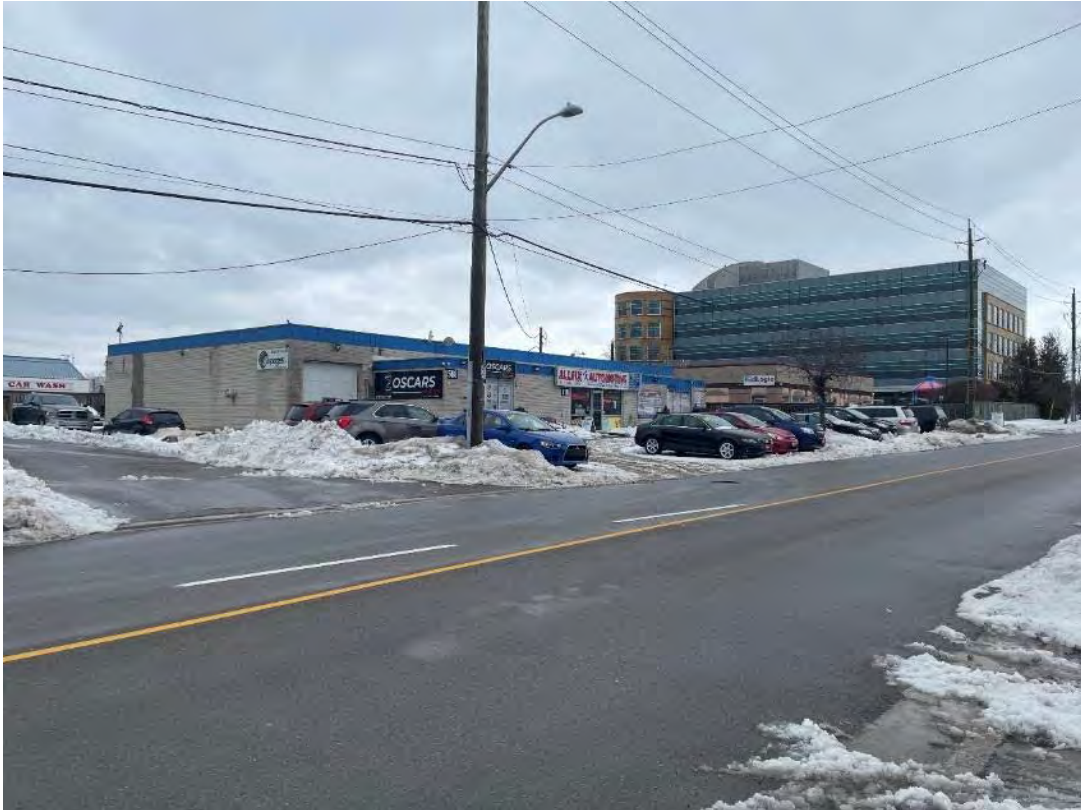
Photo 19: Auto repair shop at 570 Argus Road, approximately 90 m southeast.
